# *Bridge Inspections*

Municipalities Could be Encouraged to  
Take More Action with Improved  
Communication of Deficiencies by the  
Agency of Transportation

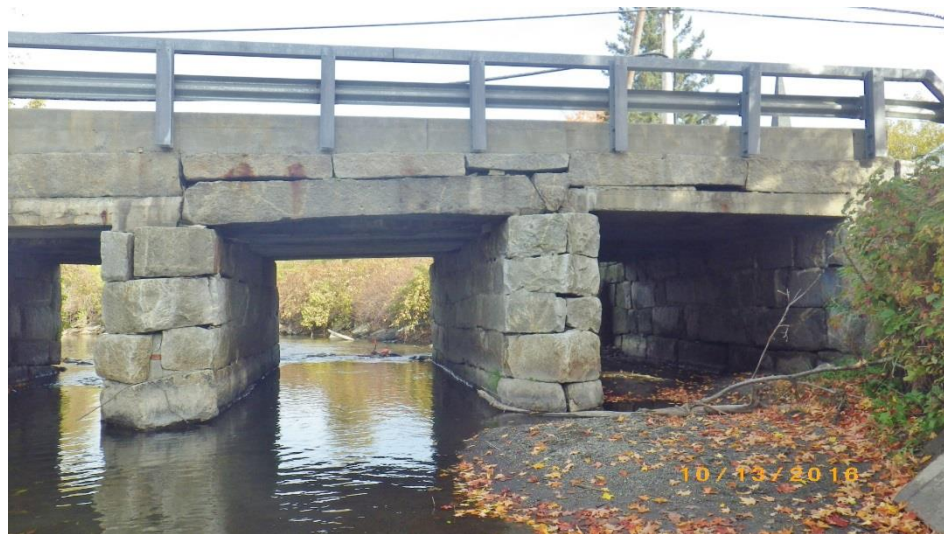
**Photo from 2016 VTrans Inspection**

Barton Village removed the debris.

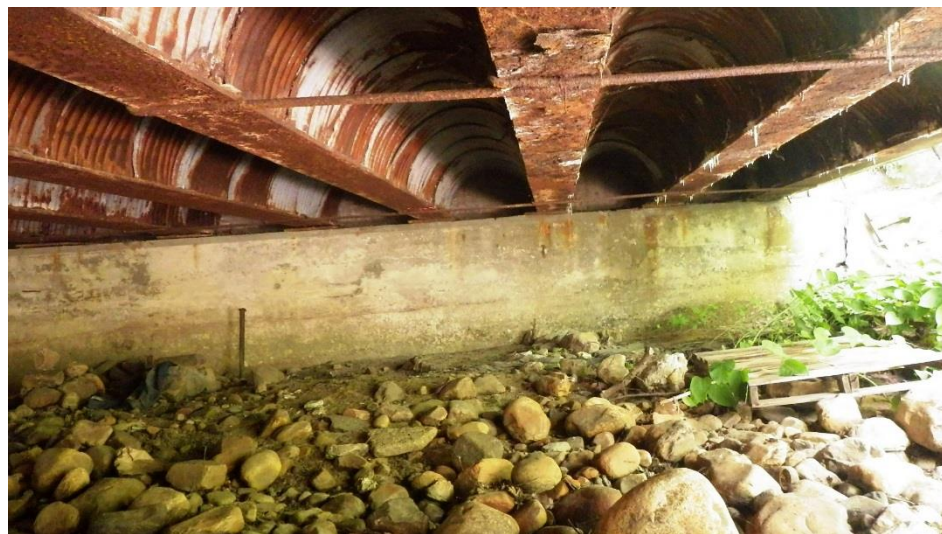
**Photo from Latest VTrans Inspection**

Bennington has not acted to address issue as of December 2017.

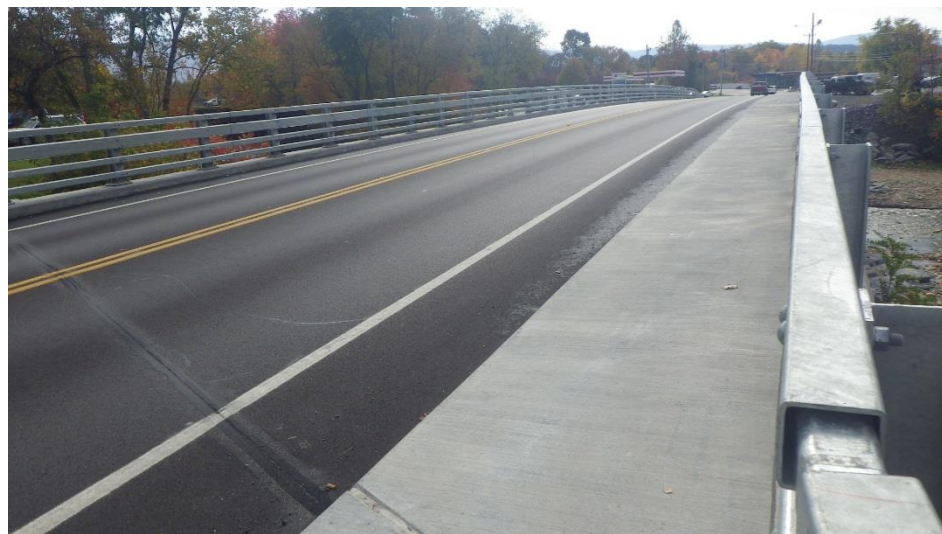
**Photo from Latest VTrans Inspection**

VTrans rehabilitated structure, including replacing the deck, as part of town highway bridge program.

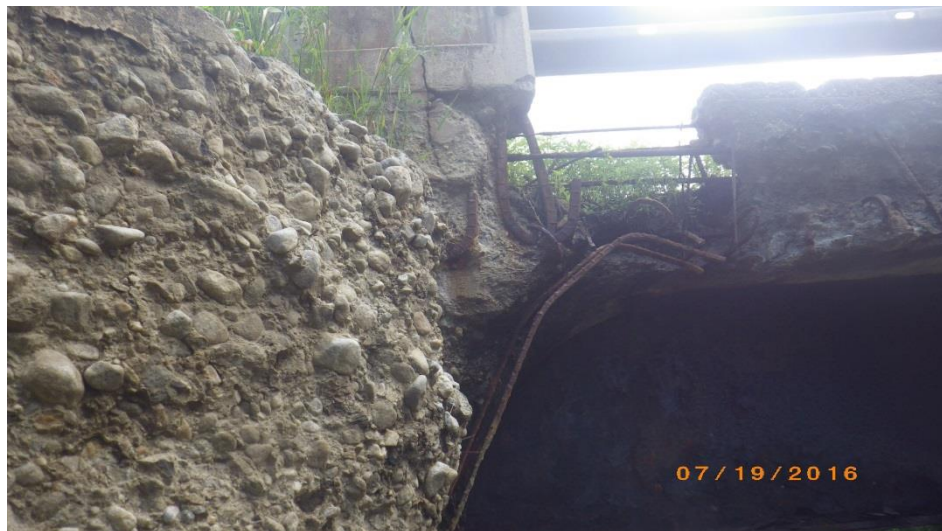
**Photo from Latest VTrans Inspection**

Burke has not acted to address issue as of November 2017.

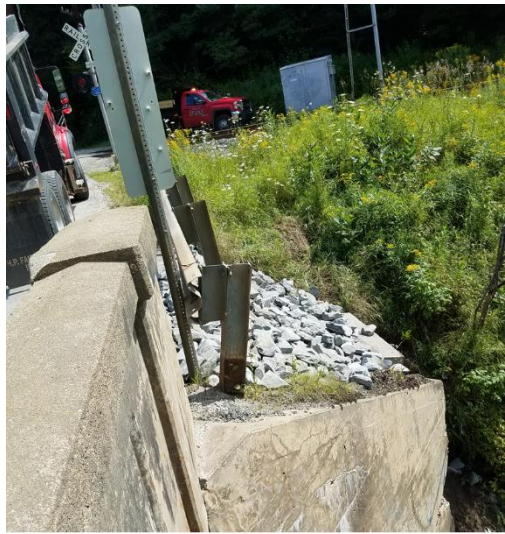
**Photo Provided by Burke**

Burke filled in area behind approach rails with stone.

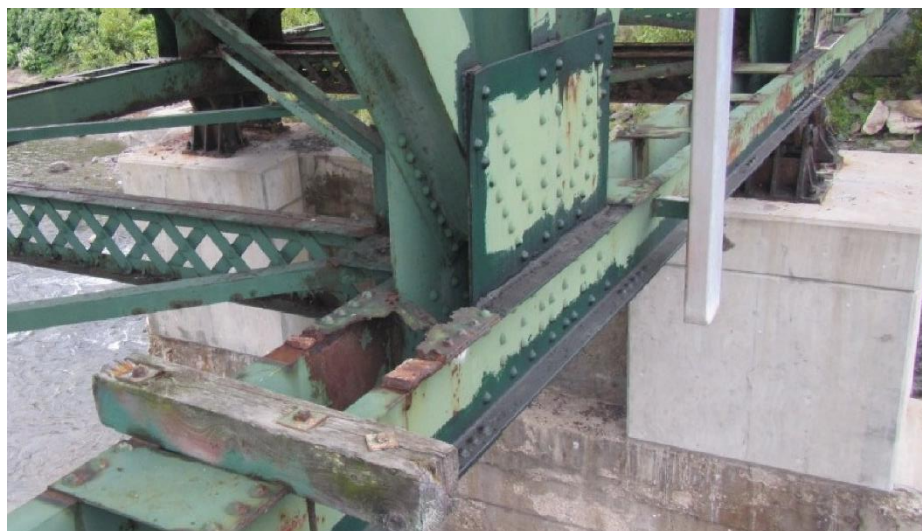
**Photo from Latest VTrans Inspection**

Hartford partially addressed issue by greasing lower node in some areas, which temporarily protects the steel elements. VTrans is evaluating alternatives as part of town highway bridge program.

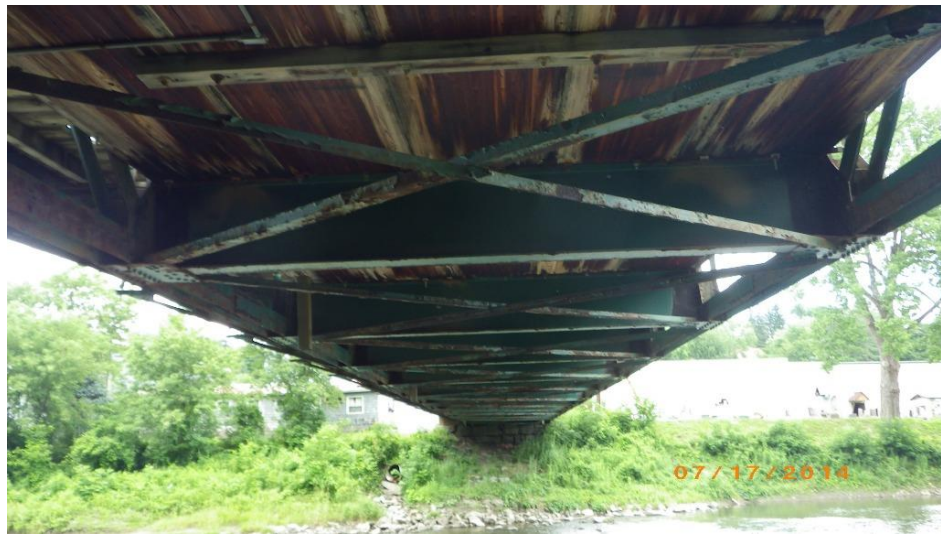
**Photo and Finding from 2014 VTrans Inspection**

Steel superstructure needs extensive cleaning and painting.

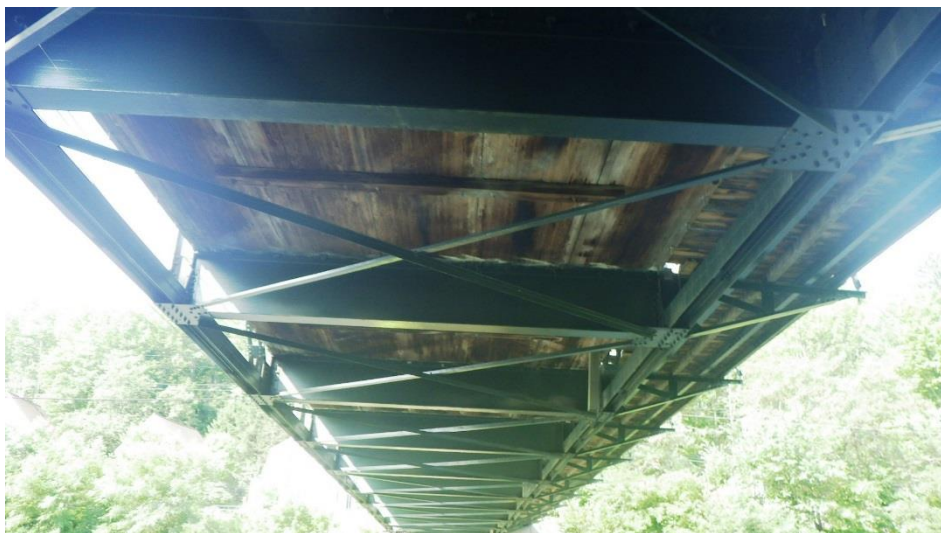
**Photo from Latest VTrans Inspection**

VTrans cleaned and painted the superstructure as part of town highway bridge program.

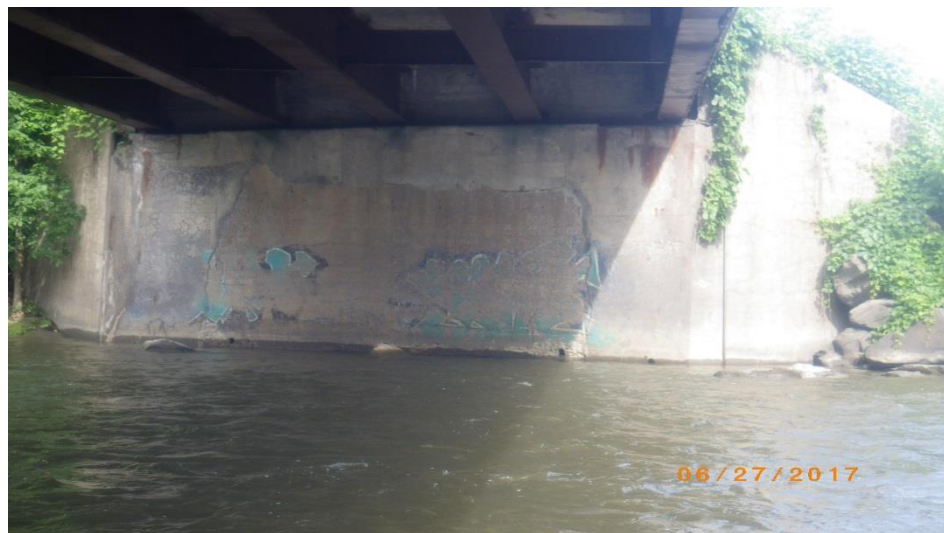
**Photo from Latest VTrans Inspection**

Montpelier has not acted to address issue as of December 2017.

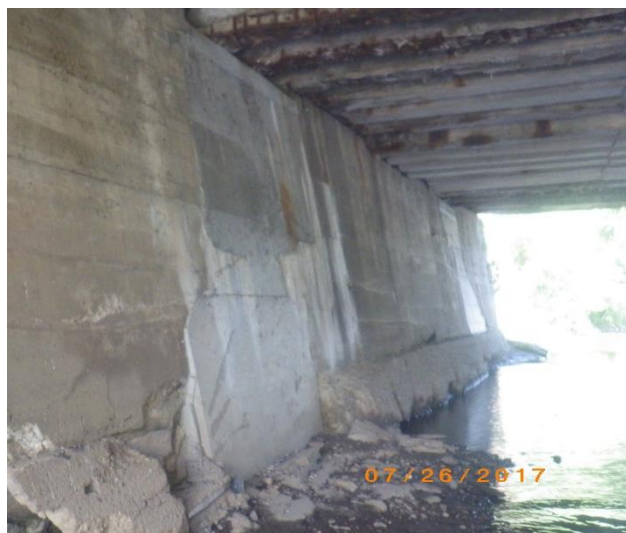
**Photo from Latest VTrans Inspection**

Montpelier patched the concrete.

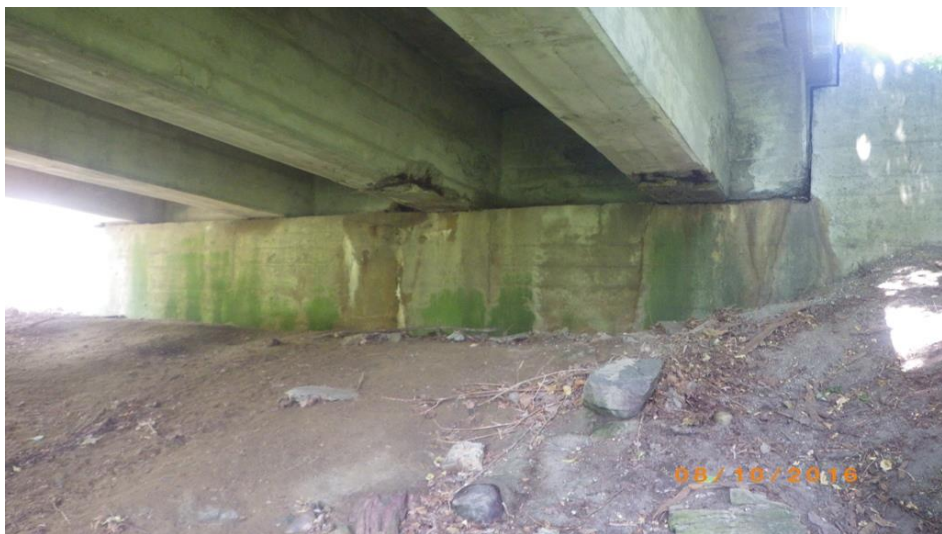
**Photo from Latest VTrans Inspection**

New Haven has not acted to address issue as of November 2017.

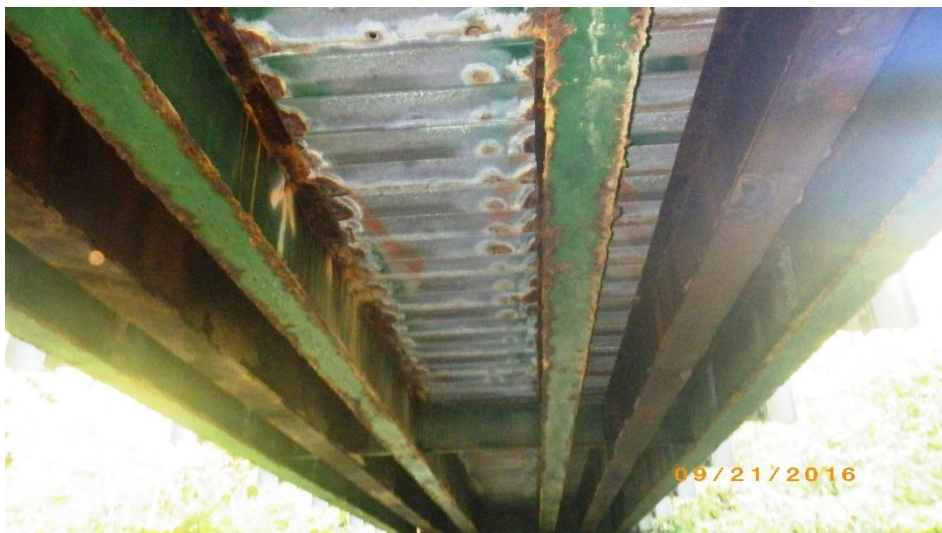
**Photo from Latest VTrans Inspection**

Newfane has not acted to address issue as of December 2017.

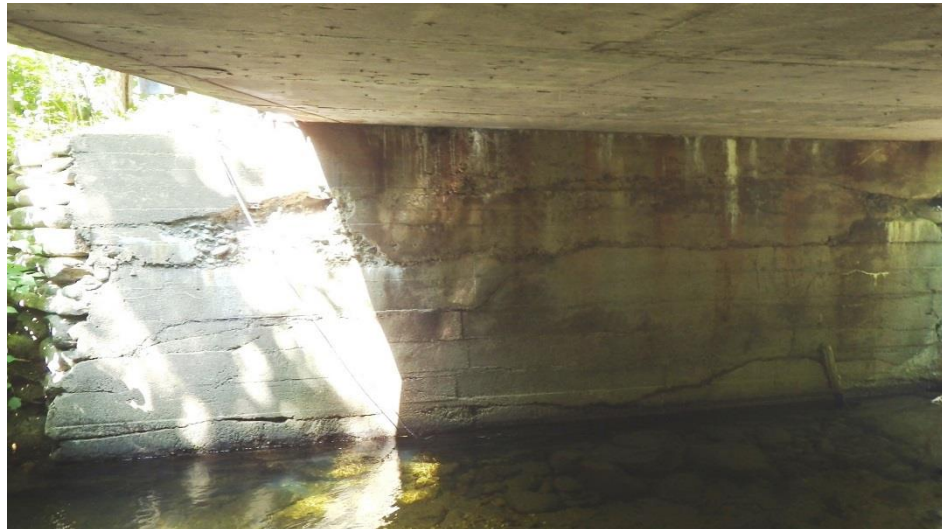
**Photo and Finding from 2014 VTrans Inspection**

Abutment 2 should be refaced.

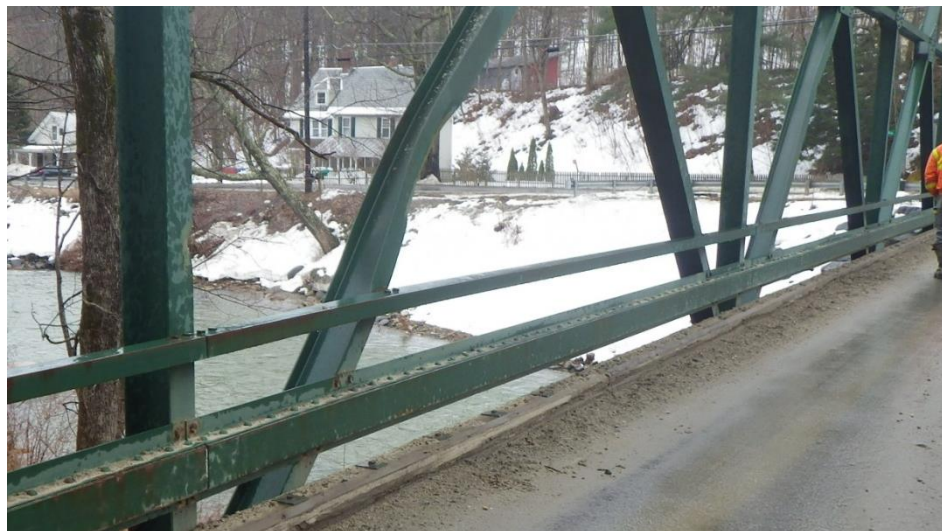
**Photo from VTrans Inspection 4/6/2017**

Newfane has not acted to address issue as of December 2017.

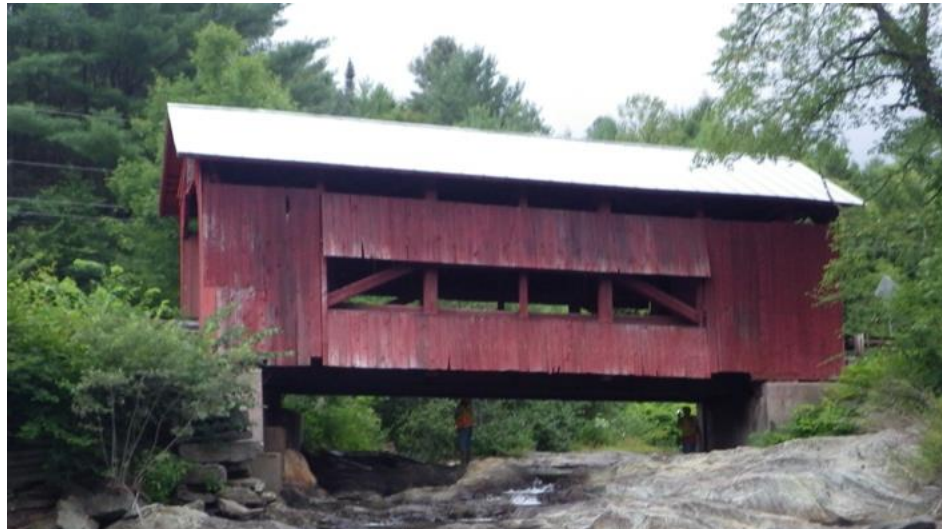
**Photo and Finding from 2014 VTrans Inspection**

Covered bridge portion needs reconstruction.

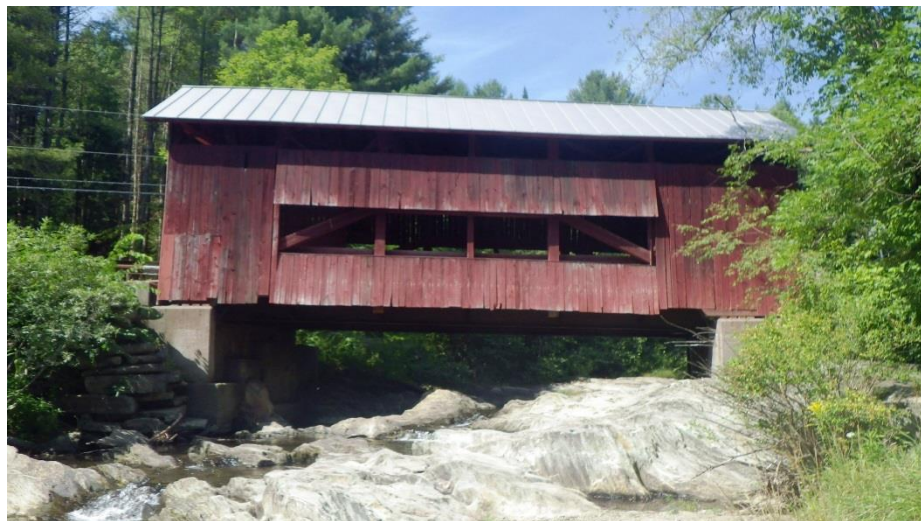
**Photo from Latest VTrans Inspection**

Northfield has not acted to address issue as of December 2017.

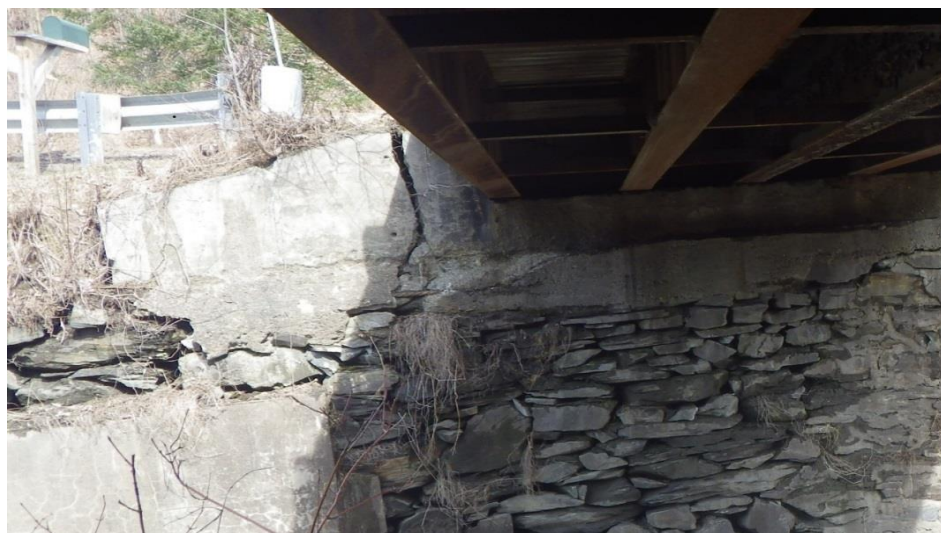
**Photo from Latest VTrans Inspection**

Northfield has not acted to address issue as of January 2018.

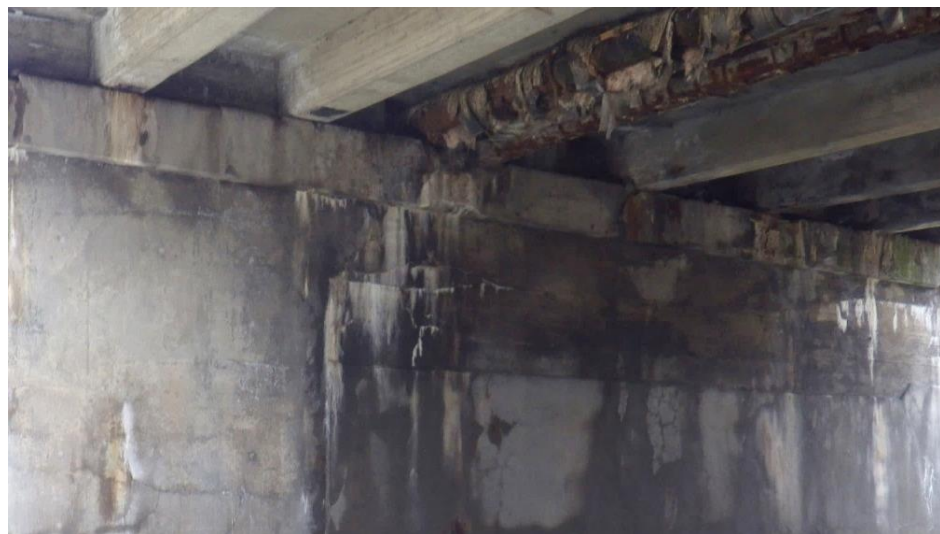
**Photo from Latest VTrans Inspection**

Northfield has not acted to address issue as of December 2017.

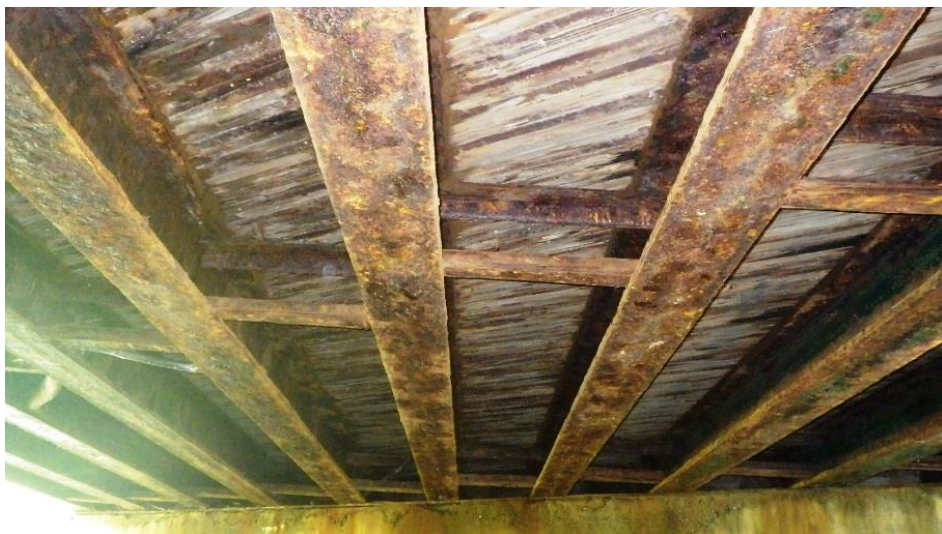
**Photo from Latest VTrans Inspection**

Northfield has not acted to address issue as of December 2017.

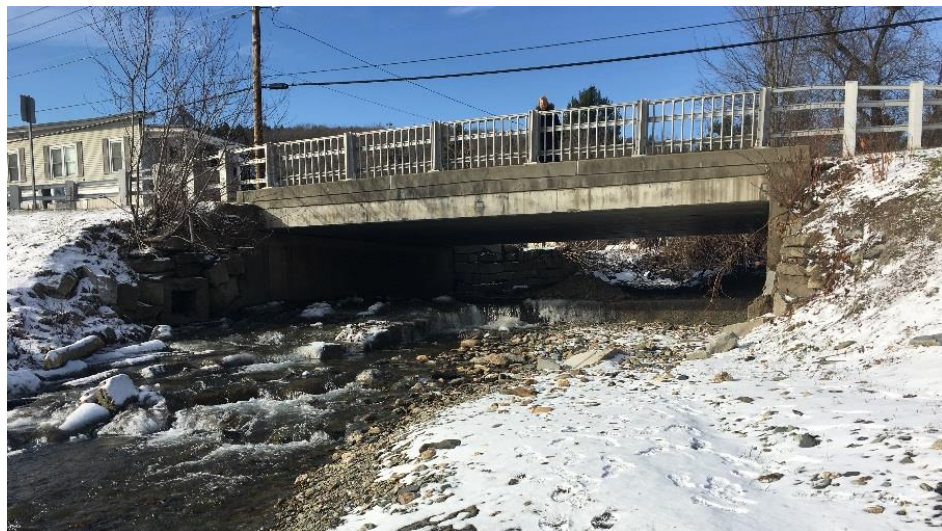
**December 2017 SAO Photo**

Northfield removed the sediment build-up.

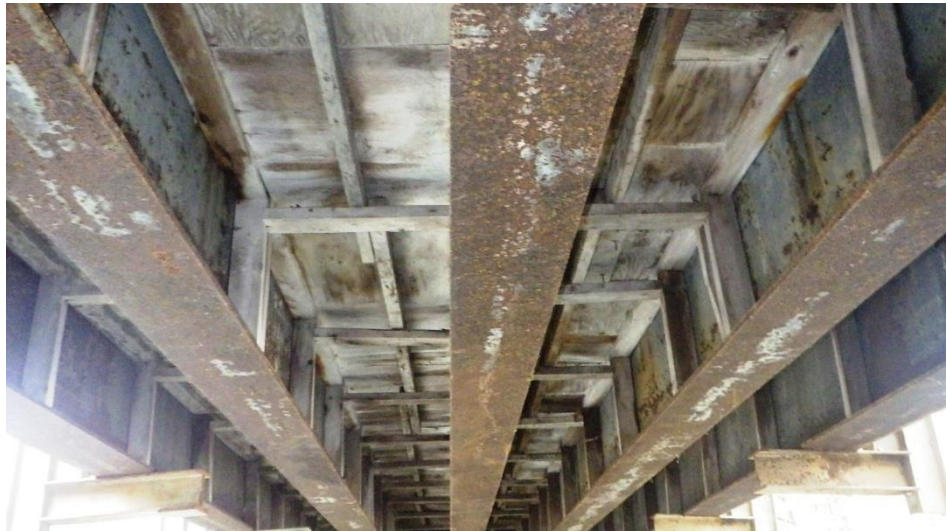
**Photo and Finding from 2015 VTrans Inspection**

Upgrade to superstructure and deck (within the next 10 years) should be considered.

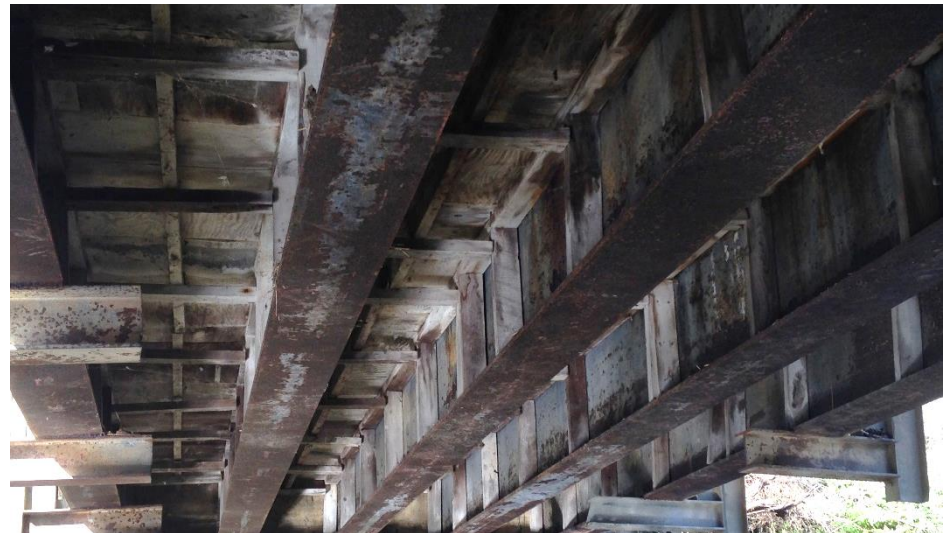
**Photo from Latest VTrans Inspection**

Randolph has not acted to address this issue as of December 2017.

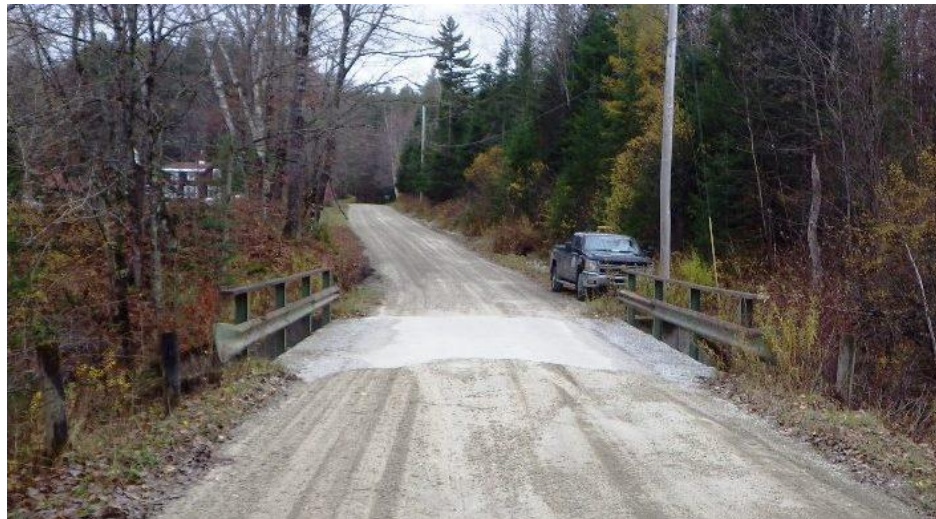
**Photo and Finding from 2014 VTrans Inspection**

Guard rail system needs upgrading.

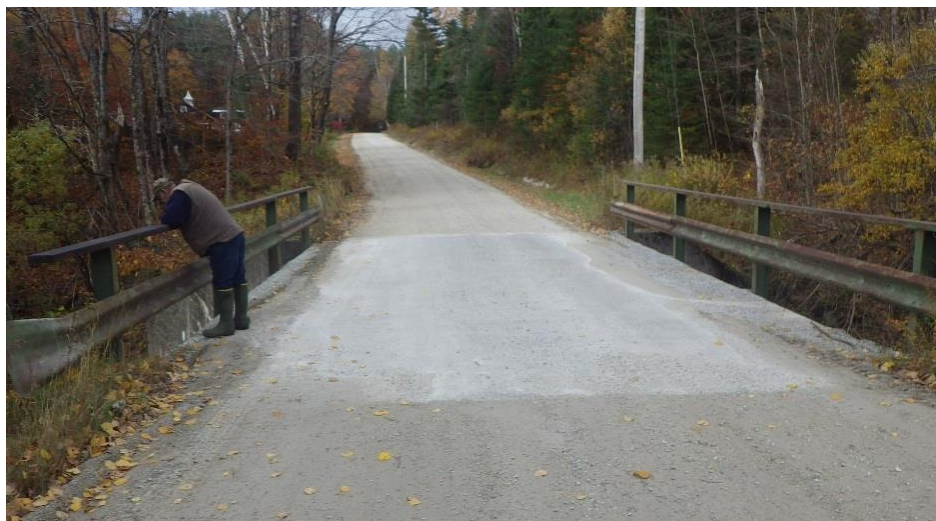
**Photo from Latest VTrans Inspection**

Shrewsbury has not acted to address issue as of November 2017.

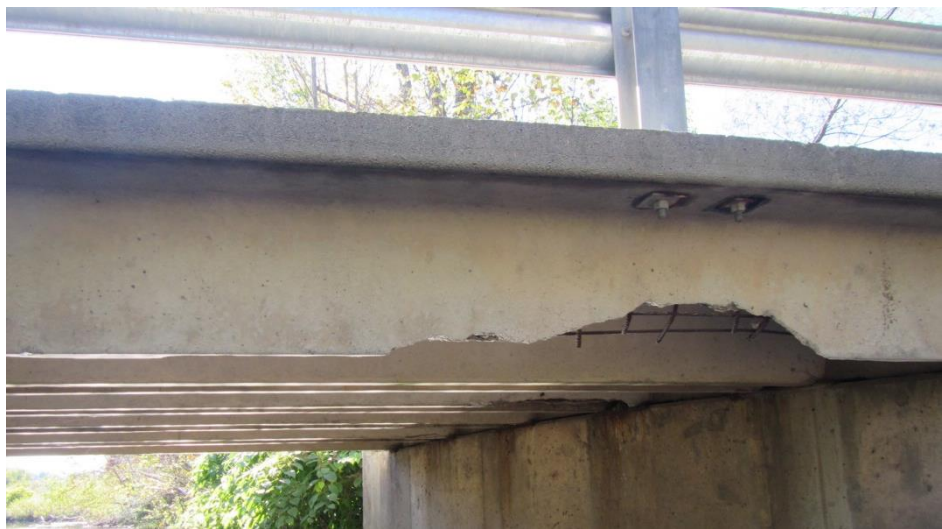
**Photo from Latest VTrans Inspection**

Tension cable is in good condition. Beam/cable unit should be replaced before tension cable rusts beyond repair.

Weathersfield has not acted to address issue as of November 2017.

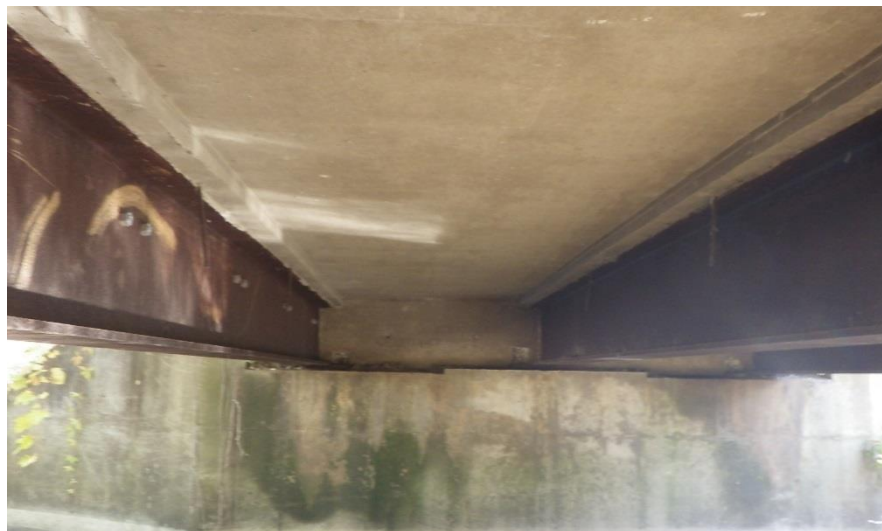
**Photo from Latest VTrans Inspection**

West Rutland has not acted to address issue as of January 2018.

Consider cleaning and painting and greasing the last few feet of the beam ends to deter further corrosion.
