**STRUCTURAL AND ELECTRICAL ASSESSMENT OF
THE BENNINGTON BATTLE MONUMENT**

**PHASE II: COMPREHENSIVE STRUCTURAL &
MATERIAL TESTING AND EVALUATION AND
OUTLINE OF RESTORATION APPROACH**

15 MONUMENT CIRCLE
BENNINGTON, VT, 05201

PREPARED FOR:
VERMONT DEPARTMENT OF BUILDINGS & GENERAL SERVICES
BGS PROJECT ID #200016

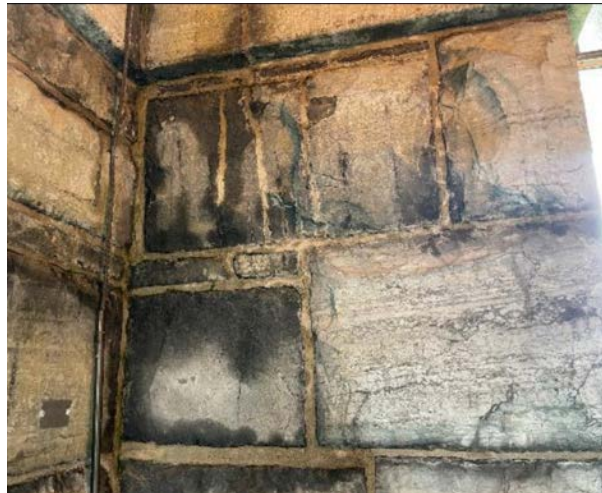
Image 39. Discoloration due to dampness in the corners of the observation platform. *Jablonski*

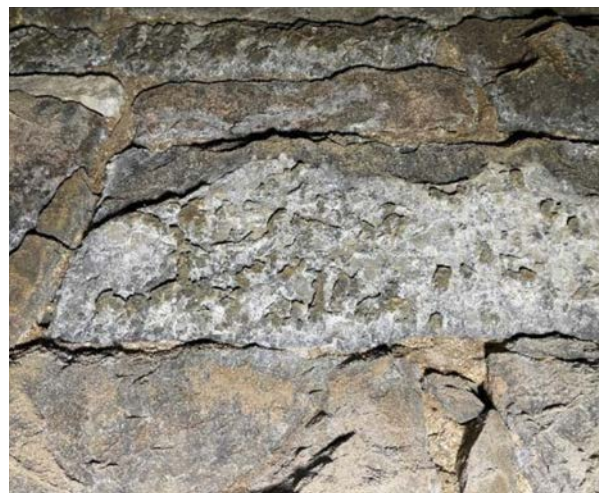
Image 34. Uneven surface texture of dark gray stone unit. *Jablonski*
